GOLDENDALE ENERGY STORAGE HYDROELECTRIC PROJECT

Federal Energy Regulatory Commission Project No. 14861

FINAL LICENSE APPLICATION Appendix B: Wetlands and Waters Delineation Report

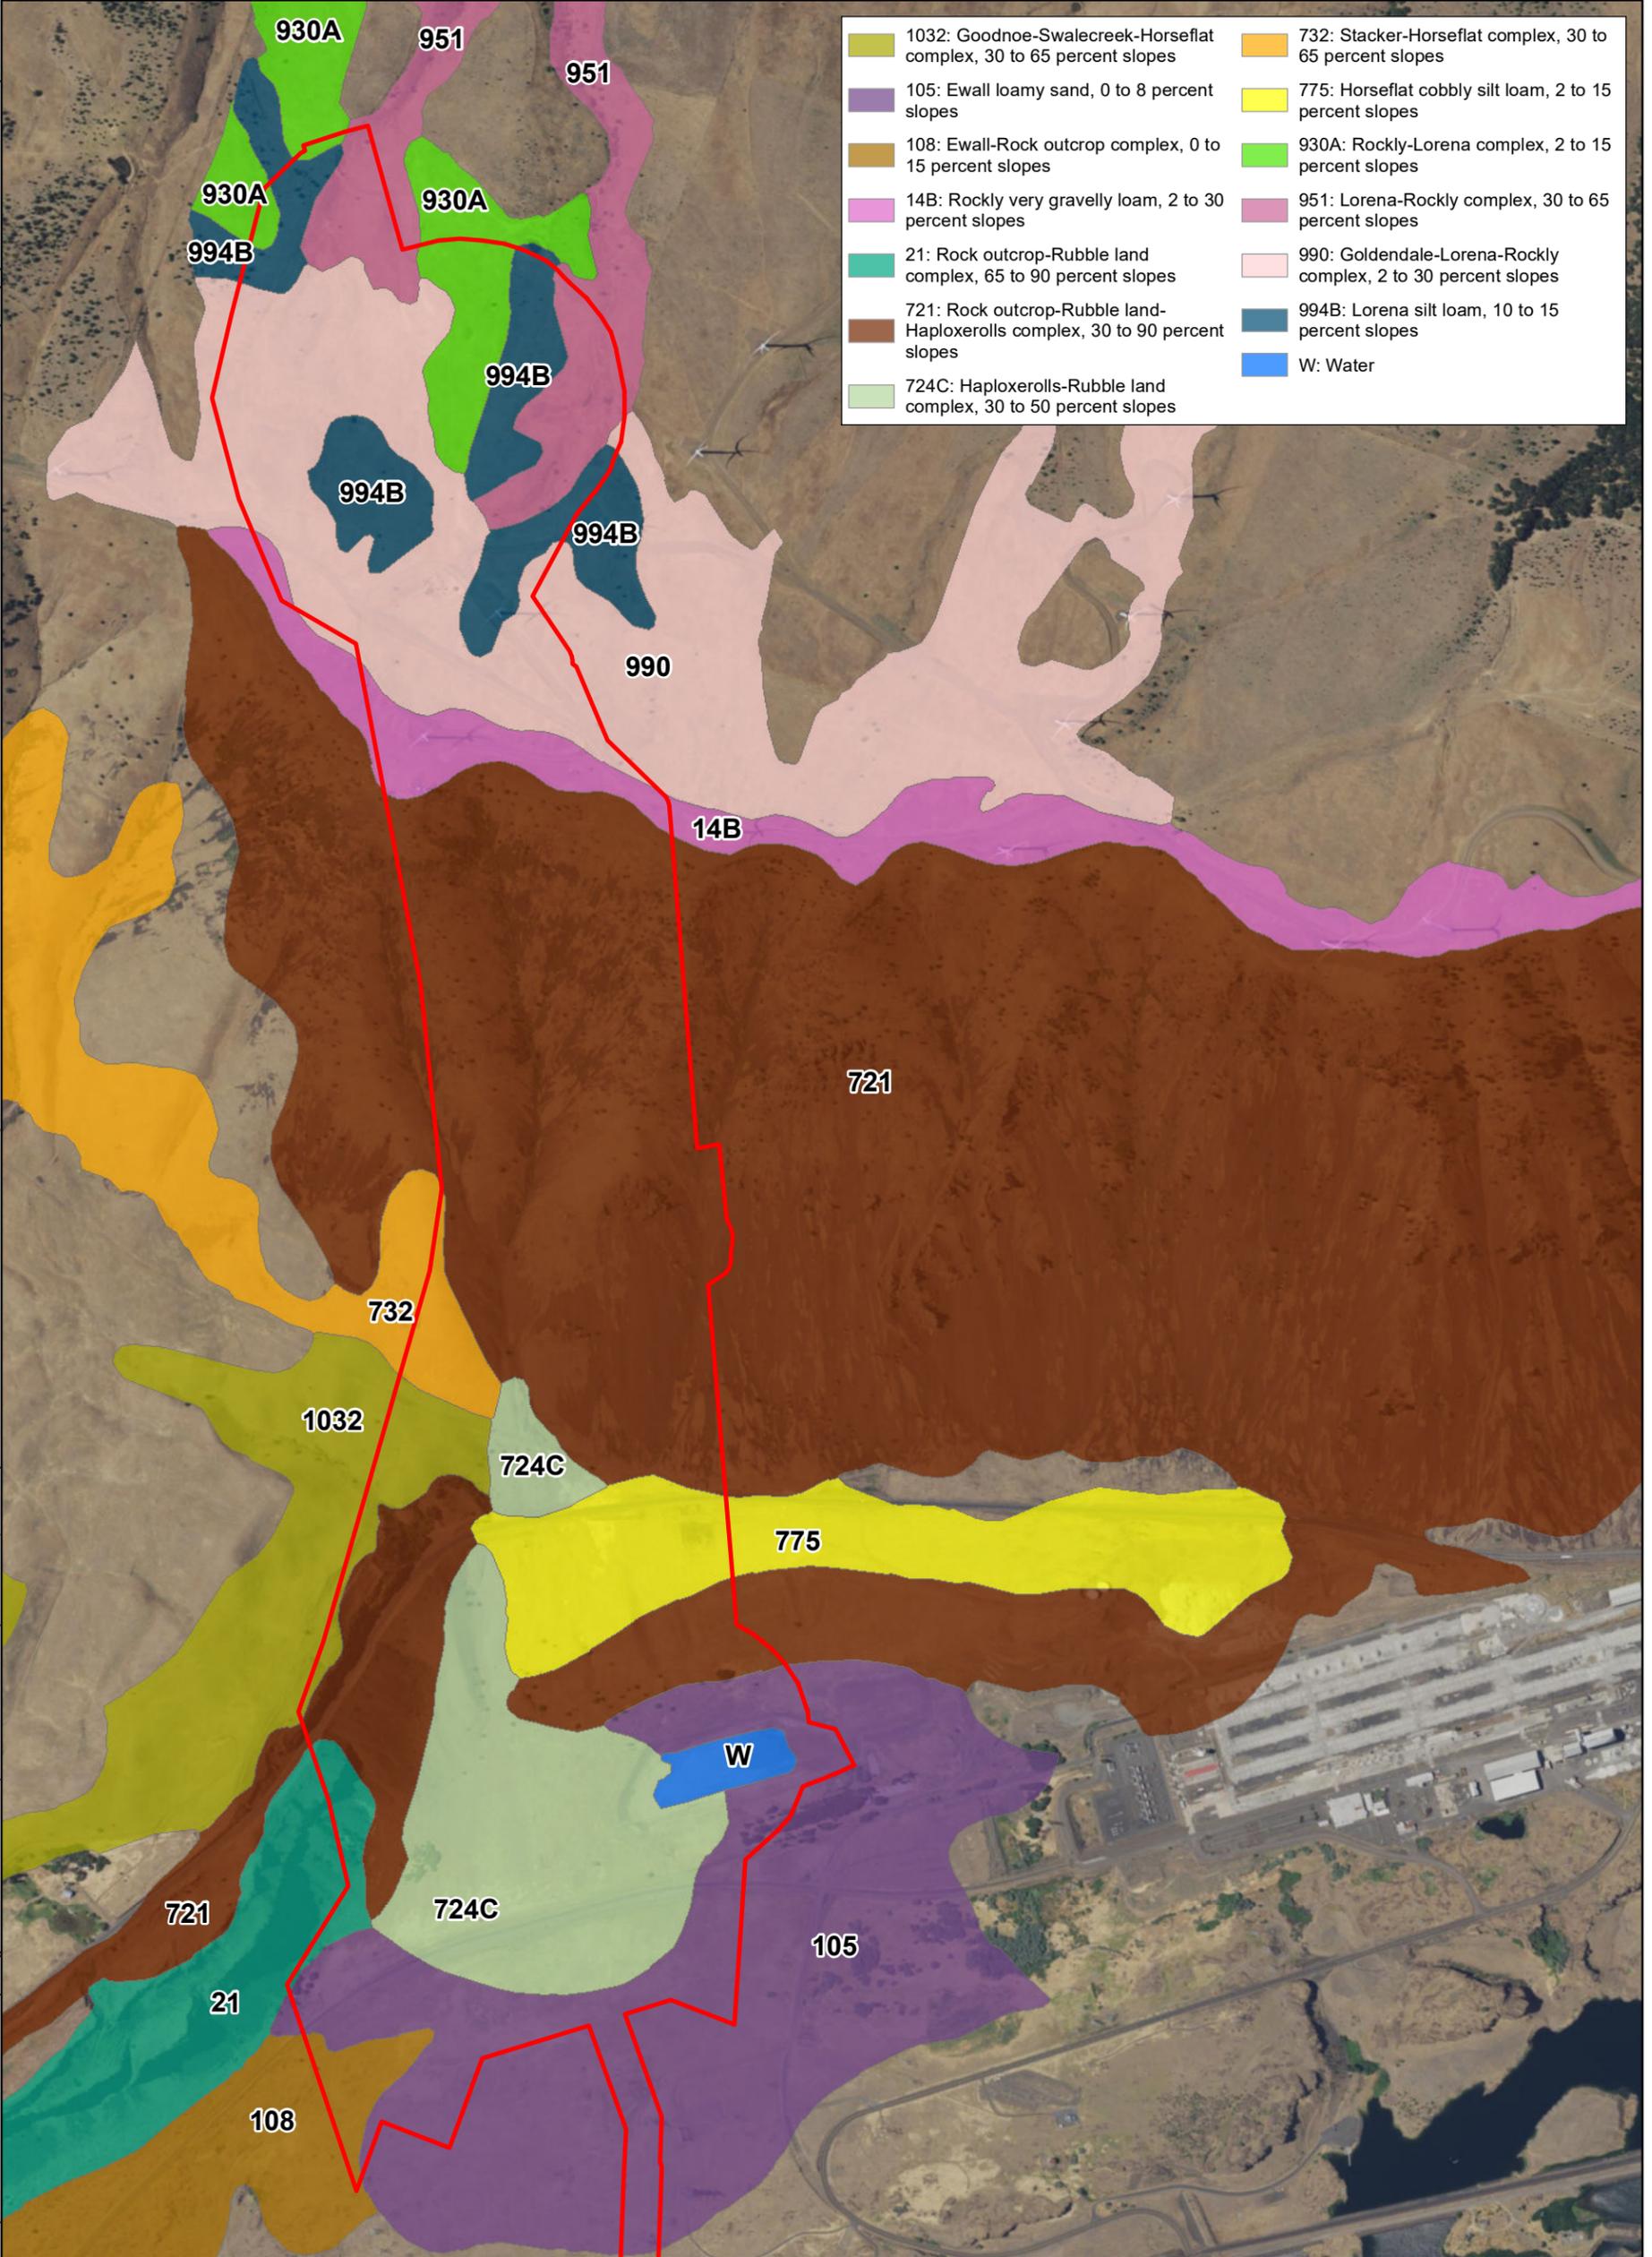
**Figure 2.1-1
NRCS Soils**

The Natural Resources Conservation Service (NRCS) soil survey identifies 13 soil map units within the study area (Table 2.1-1; Figure 2.1-1). None of the soil map units are considered hydric (USDA/NRCS 2019). The NRCS data identifies a portion of the study area south of Highway 14 as “water”. This area corresponds to the former location of an artificial water impoundment associated with the Columbia Gorge Aluminum smelter (and later the NSC smelter). Review of Google Earth imagery suggests this impoundment was demolished between 2003 and 2005.

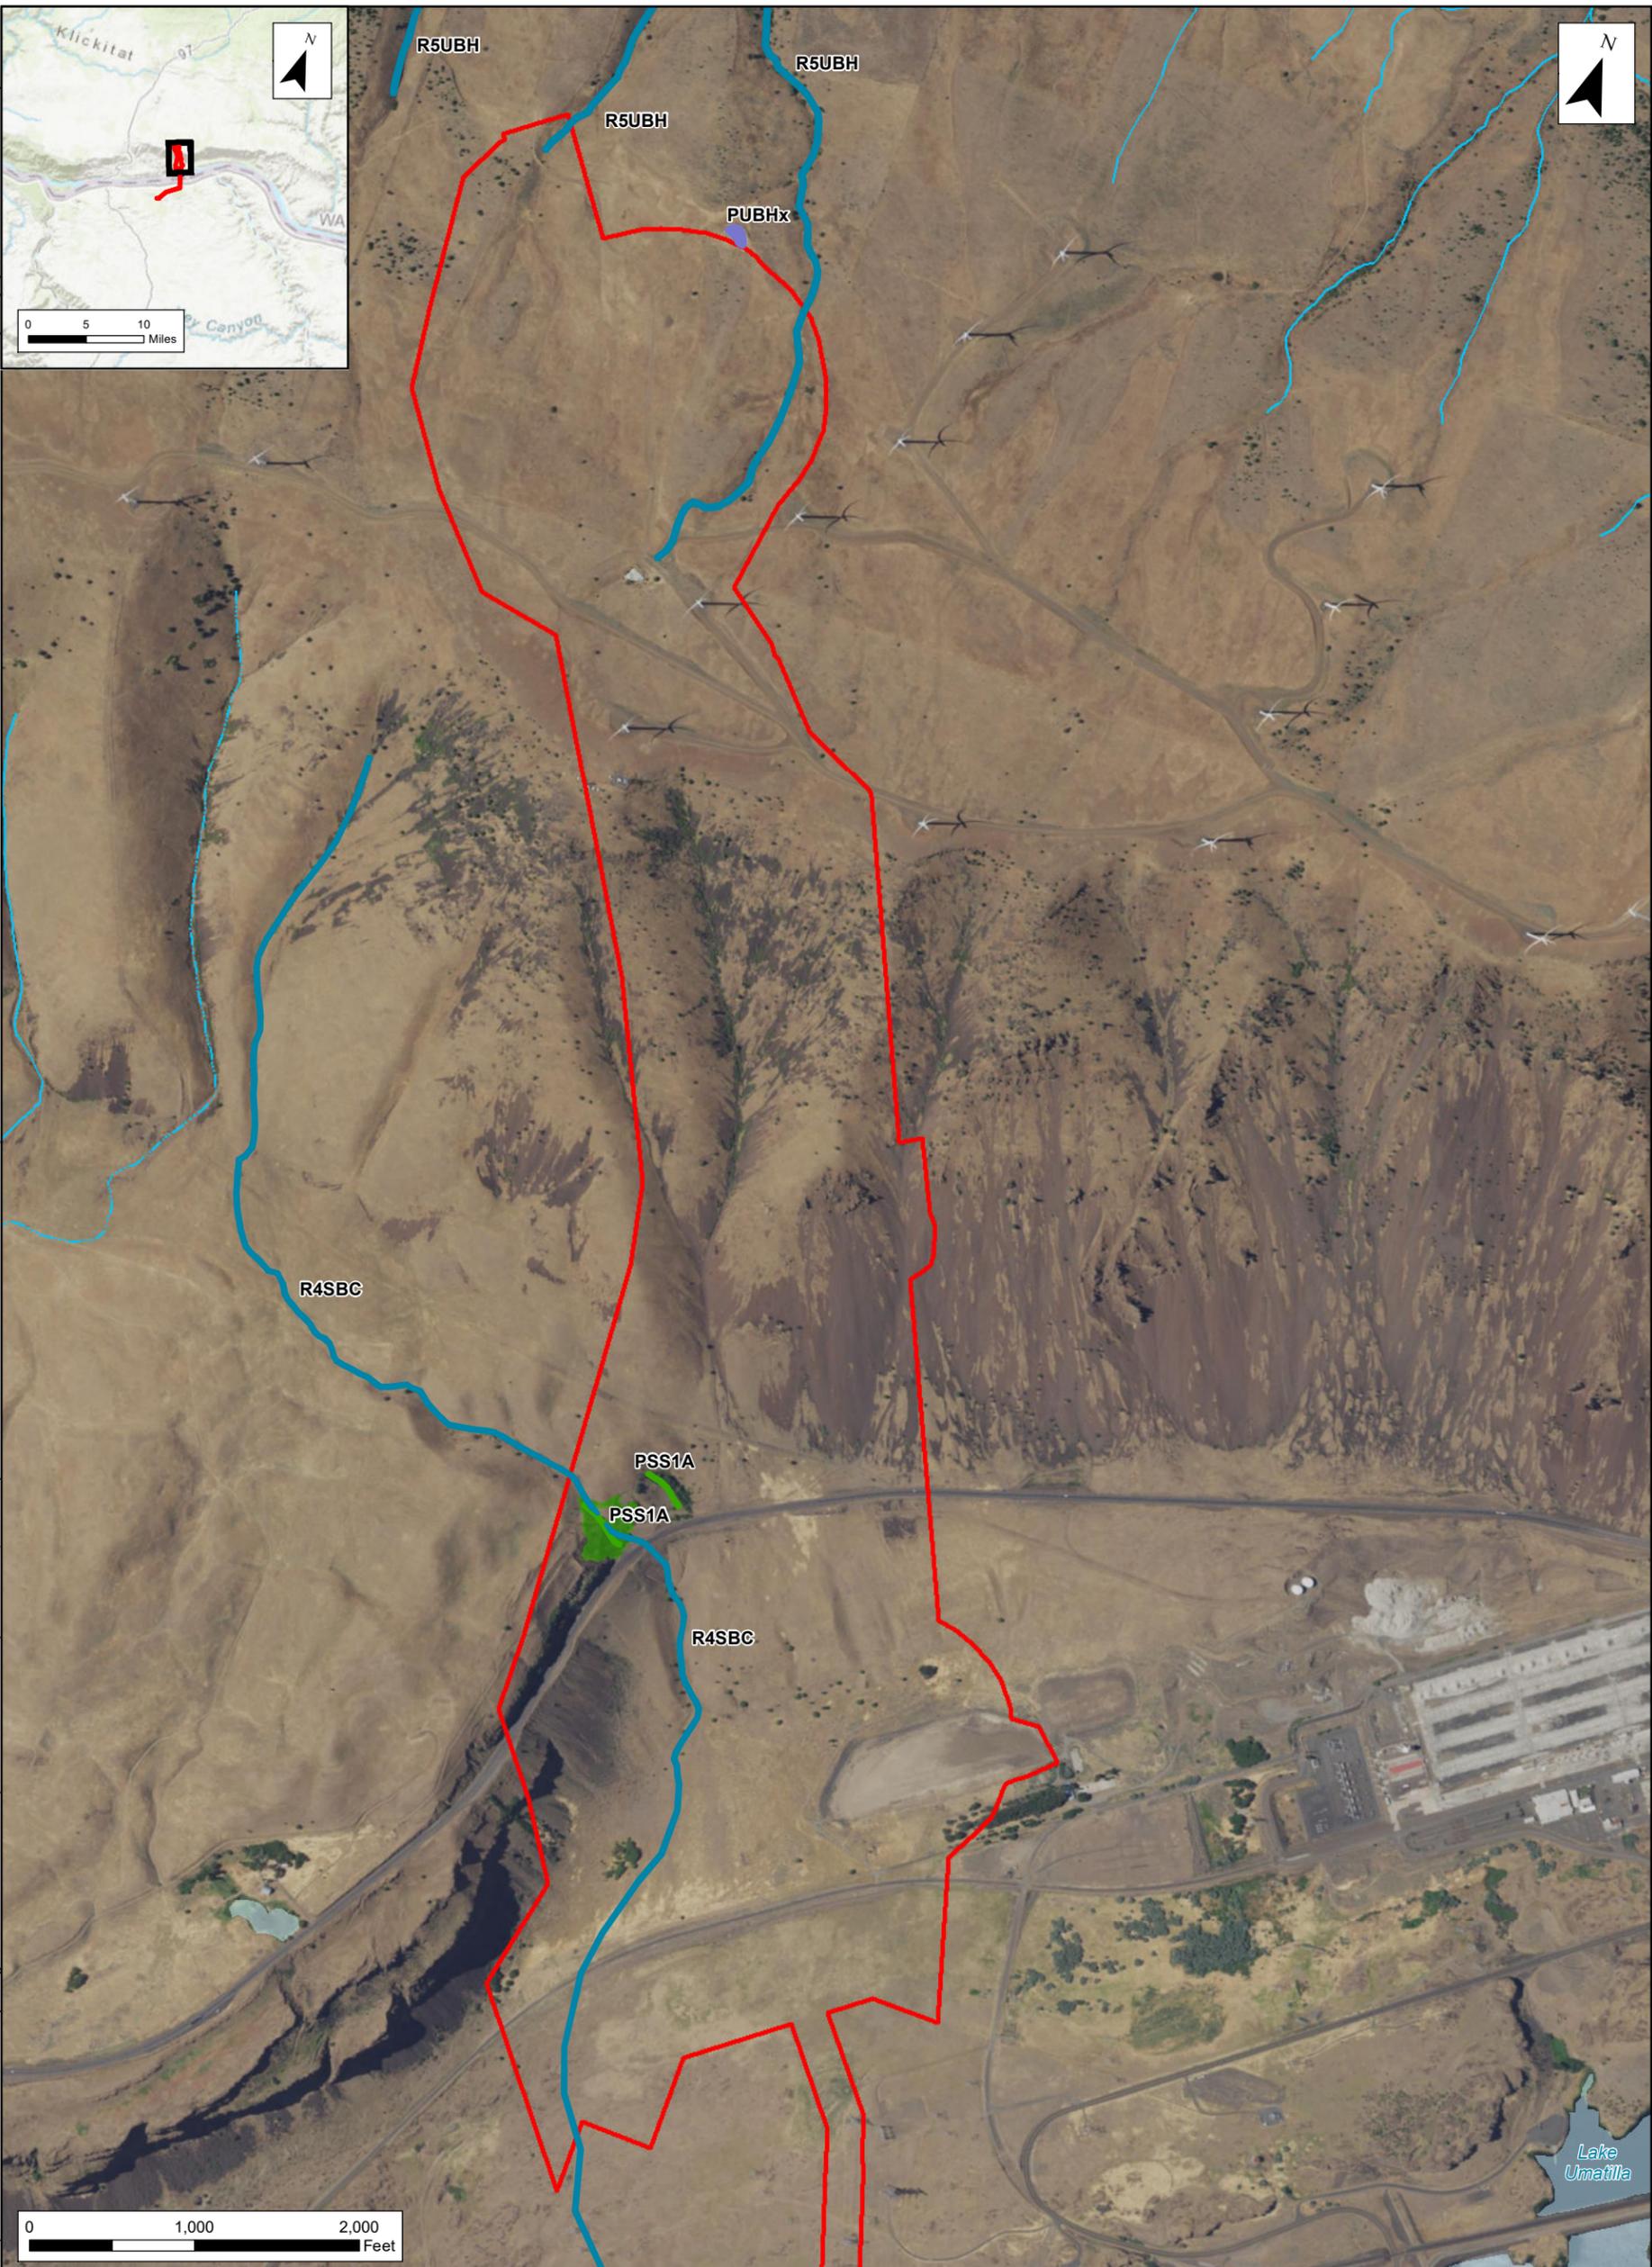
Figure 4-1
NHD and NWI Mapped Features
 Wetland and Waters Delineation Report
 Goldendale Energy Storage Project
 Goldendale, WA

ERM delineated two ephemeral streams, two ponds, one intermittent stream and one seep within the study area (Figure 4-1). Table 4.7-1 summarizes the results of the field investigation.

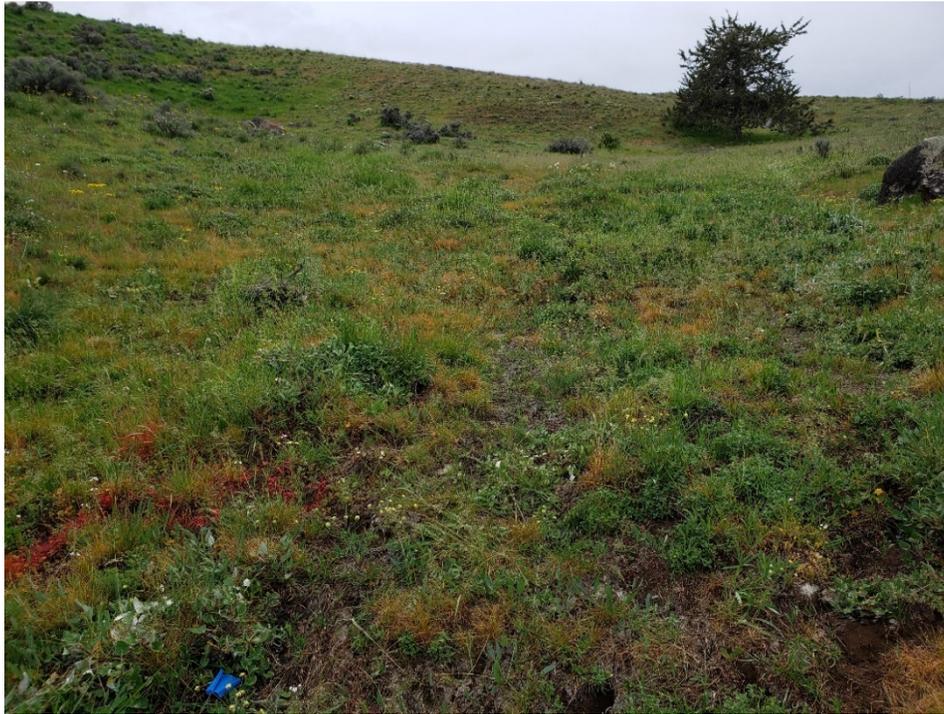
Photo 1: DP-1 Vegetation, Looking South

Remarks: Algal matting present in swale.
Soil dry and crumbly, low soil moisture.

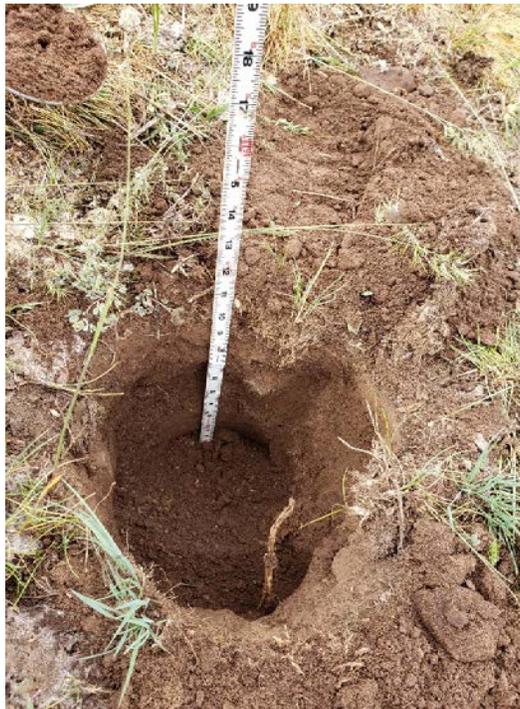
Photo 2: DP-1 Soil Pit

Depth (inches)	Matrix		Redox Features				Texture ³	Remarks
	Color (moist)	%	Color (moist)	%	Type ¹	Loc ²		
0-8	10YR 3/3	100	NA				silt loam	
8-11	10YR 3/3	98	10YR 4/4	2	C	M	silt loam

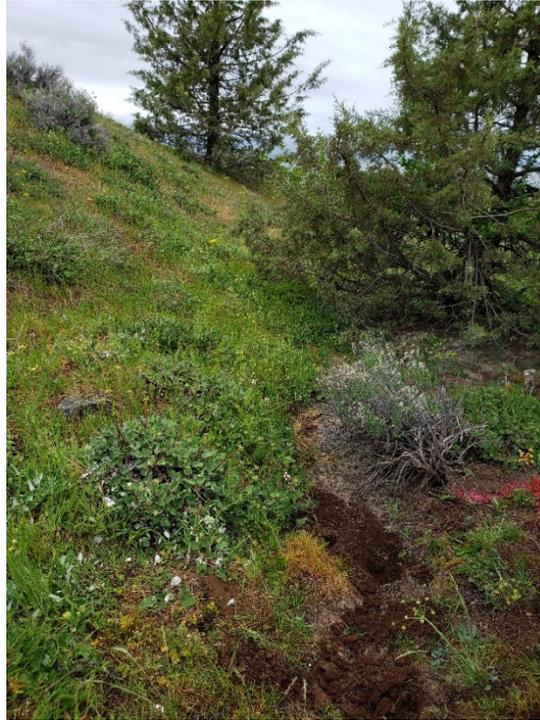
Photo 3: DP-2, Near Beginning of S7. Vegetation, Looking North

Feature S7 is identified as a perennial watercourse in both the NHD and NWI datasets that is located near the upper reservoir. However, based on observations during the May 2019 wetland and waters delineation this feature is an ephemeral stream channel that is 16 to 24 inches wide, 1 to 3 inches deep, and extends approximately 995 feet into the study area. The NHD and NWI both show this feature is about 950 feet longer and connects to pond P2; however, there is no evidence of an OHWM between P2 and the upper extent of S7 as mapped by ERM. Evidence of an OHWM included an incised bed and bank, sediment sorting and debris wracking. Substrate consists of small cobbles, gravels, and fines. Although no flowing water was observed, much of the substrate was covered with algal matting. Vegetation along S7 consists of bulbous bluegrass (*Poa bulbosa*), cheatgrass (*Bromus tectorum*), smallflower woodland-star (*Lithophragma parviflorum*), barestem biscuitroot (*Lomatium nudicaule*), and Hood River milk-vetch (*Astragalus hoodianus*).

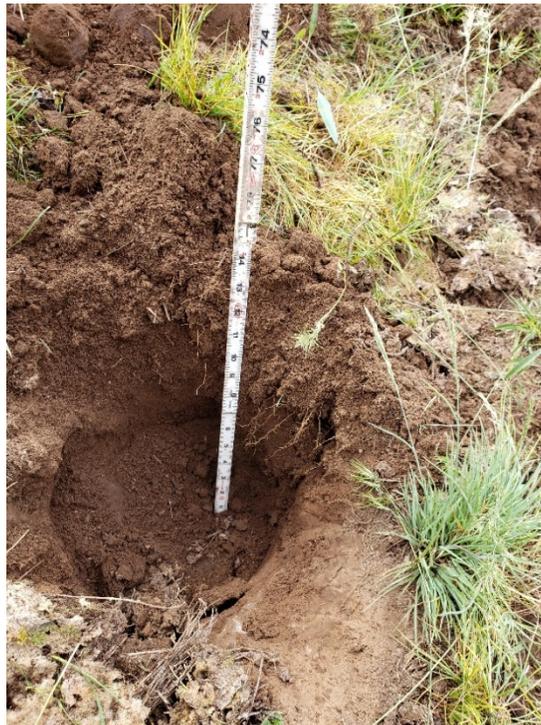
Photo 4: DP-2 Soil Pit

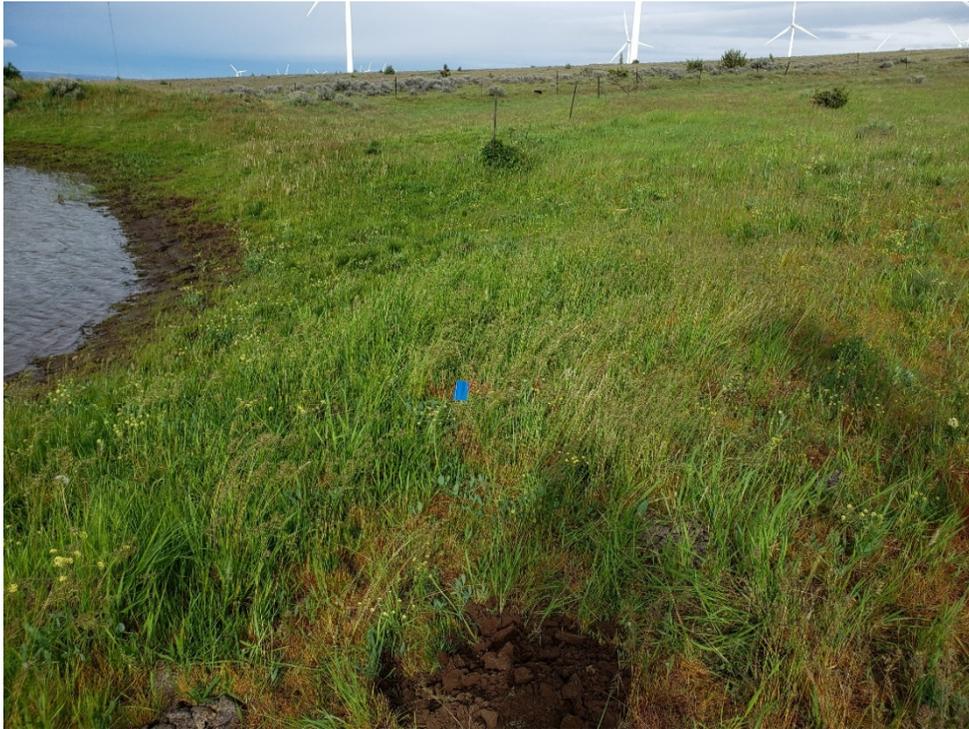
Photo 5: DP-3 (at P1) Vegetation, Looking East

Feature P1 is identified as a perennial pond in both the NHD and NWI datasets that is located in the northern portion of the study area. The pond appears to be artificially created in uplands to support cattle grazing on the surrounding property; there is no outlet or channel connecting it to S7. At the time of the May 2019 delineation, the pond appeared to be nearly full. Unidentified emergent vegetation was observed growing sparsely in about 1 to 2 feet of standing water. Review of Google Earth aerial imagery suggests that the pond partially dries up but retains a small amount of water throughout the year. The pond is approximately 0.2 acre in size, of which approximately 0.001 acre is within the study area.

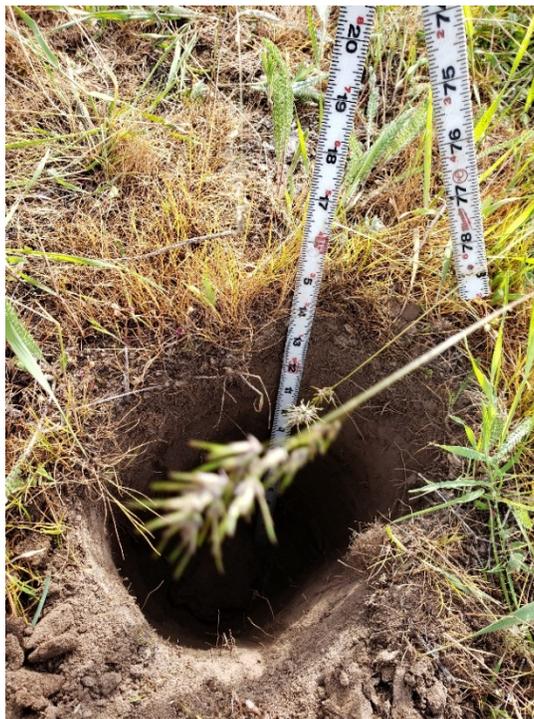
Photo 6: DP-3 (at P1) Soil Pit

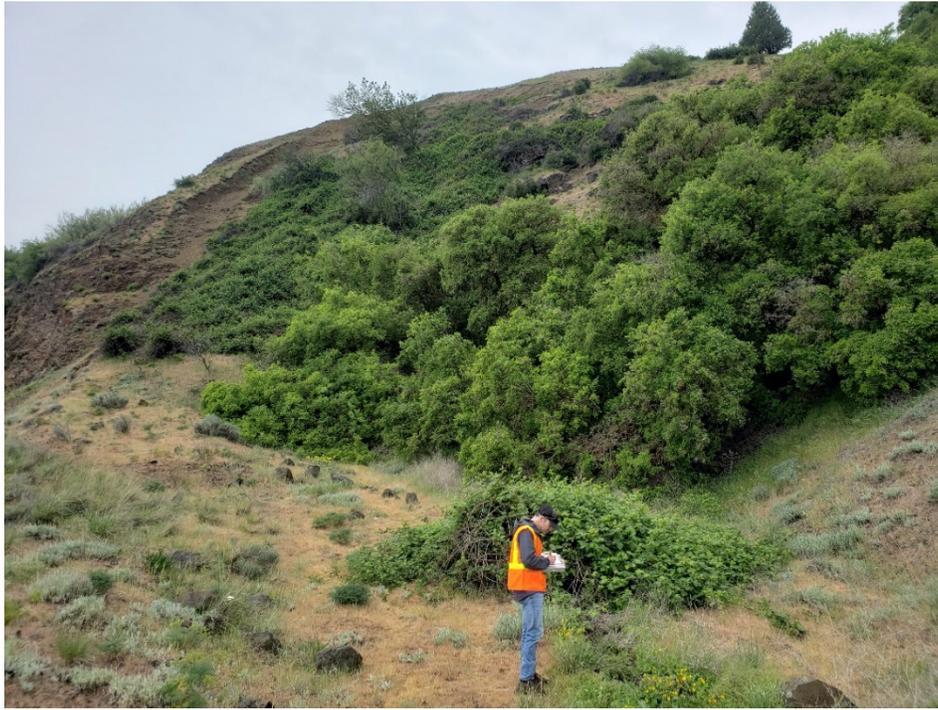
Photo 7: S17 Intermittent Stream, Looking West

Feature S17 is identified as an intermittent watercourse in both the NHD and NWI datasets that crosses Highway 14 near the lower reservoir. Additionally, the NWI identifies a palustrine shrub-scrub wetland immediately upslope of the highway. Field observations during the May 2019 delineation confirmed this feature is an intermittent stream channel; however, there is no shrub-scrub wetland present. The stream channel is about 24 inches wide and 1 to 3 inches deep, with substrate consisting of mud and fine gravels. Evidence of an OHWM included a defined bed and bank and sediment sorting. The channel begins above the highway and is conveyed beneath the highway through a metal culvert. Flowing water 1 to 3 inches deep was observed above the highway; however, no water was observed exiting the culvert at the outlet on the southeast side of the highway. Below the culvert outlet, the stream channel extends only about 20 feet where it resembles a grassy swale that lacks the OHWM indicators observed above the highway. These conditions suggest the culvert may be damaged and that most of the stream flow goes subsurface beneath the highway before reaching the culvert outlet. Vegetation along S17 consists of netleaf hackberry (*Celtis reticulata*), Himalayan blackberry (*Rubus armeniacus*), seep monkeyflower (*Mimulus guttatus*), bedstraw (*Galium* sp.), bulbous bluegrass, and cheatgrass.

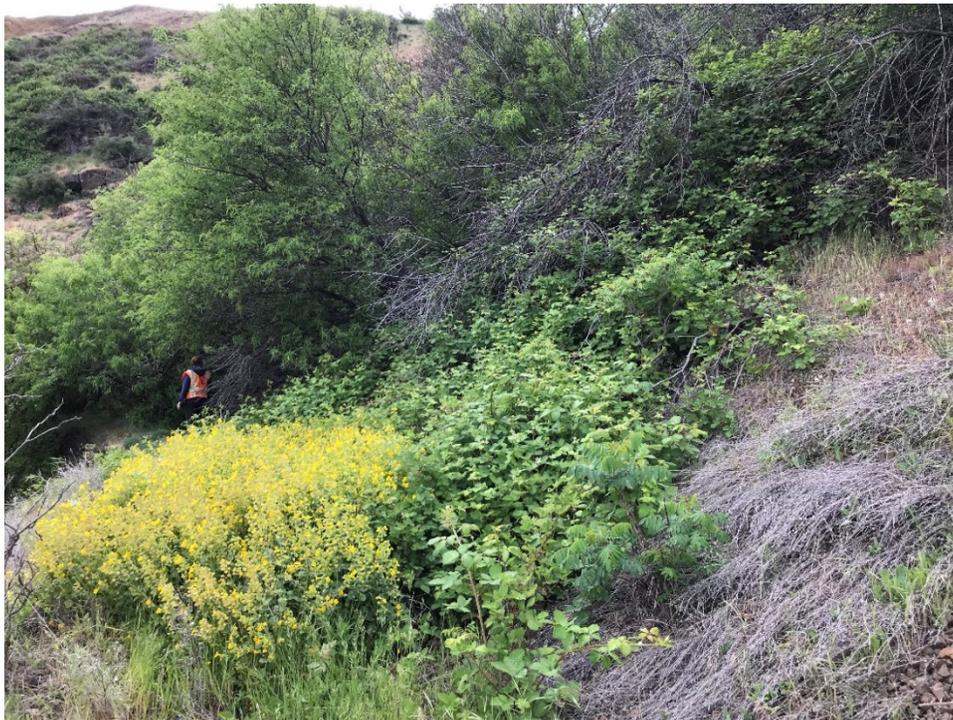
Photo 8: W6 Wetland with Seep, Looking Southwest

W6 is a palustrine, emergent wetland associated with a seep on a hillslope roadcut along Highway 14. Vegetation observed in wetland feature W6 included seep monkeyflower (*Mimulus guttatus*, OBL). Adjacent to the wetland feature in the riparian corridor surrounding the S17 channel vegetation included tree and shrub netleaf hackberry (*Celtis reticulata*, FAC) and Himalayan blackberry (*Rubus armeniacus*, FAC). Additional species observed in and adjacent to S17 and W6 included bedstraw (*Galium* sp., FACU-UPL), dock (*Rumex* sp., generally FACW), bulbous bluegrass (*Poa bulbosa*, FACU), cheatgrass (*Bromus tectorum*, UPL), milkweed (*Asclepias* sp., FAC-UPL), and blue wildrye (*Elymus glaucus*, FACU). Soil pits were not

excavated in the W6 wetland due to flowing and standing water within the feature and plot. Additionally, the seep is located on an old roadbed consisting of compacted rock and gravel, which could not be excavated. Therefore hydric soil is assumed present. Hydrology in the wetland was observed as flowing and standing water. The wetland does not appear to have a surface connection to S17 located about 70 feet downslope.

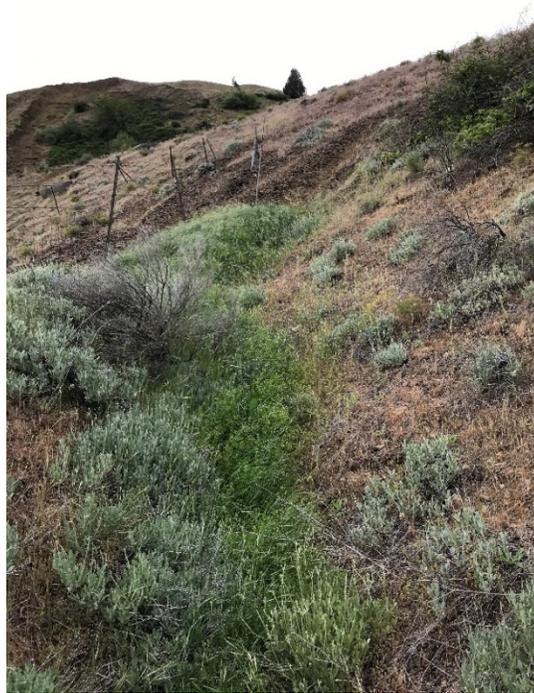
Photo 9: S17 at Culvert Outlet Located below Highway 14, Looking West

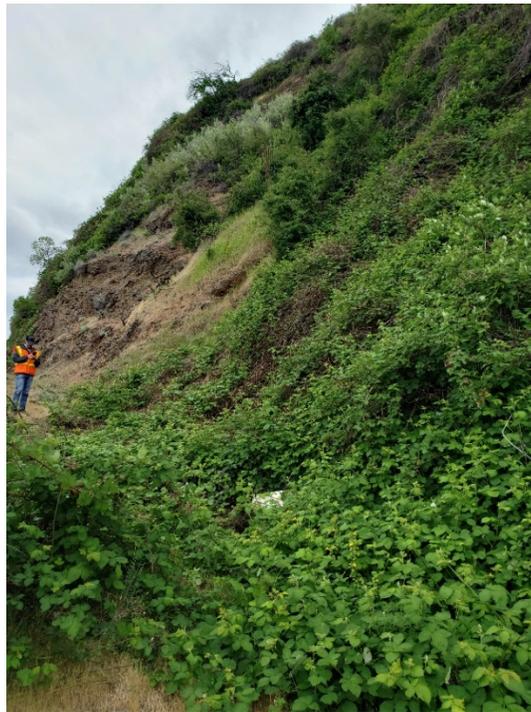
Photo 10: S24, Looking Southwest

Feature S24 is not identified in either the NHD or NWI datasets, but appears to groundwater seep located along the excavated hillside above Highway 14 near the lower reservoir. Water flows down the hillside into a roadside drainage ditch and into a culvert that conveys the water to east side of the highway. Similar to S17, no flowing water was observed existing the culvert outlet. Vegetation within the seep consists primarily of Himalayan blackberry and black cottonwood (*Populus trichocarpa*) saplings.

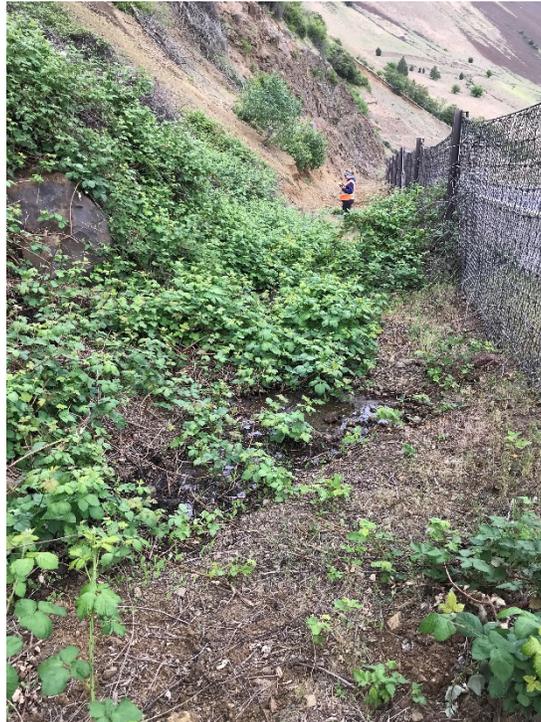
Photo 11: S24, Looking Northeast

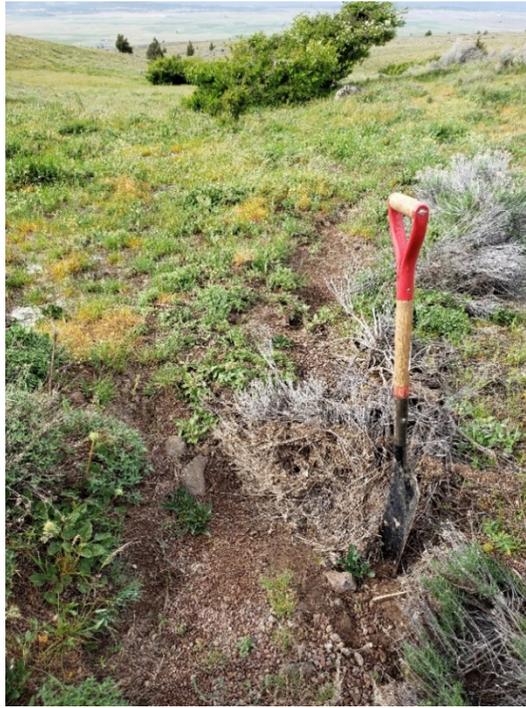
Photo 13: S7, Looking North

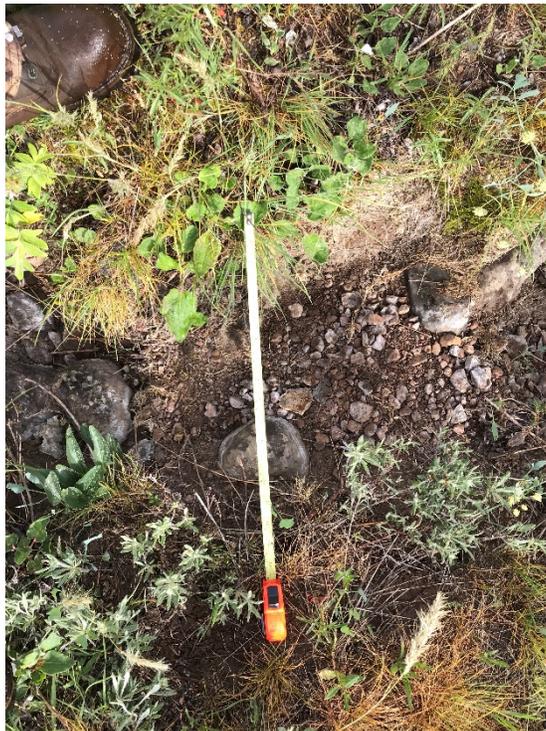
Photo 14: S7 Width Measurement

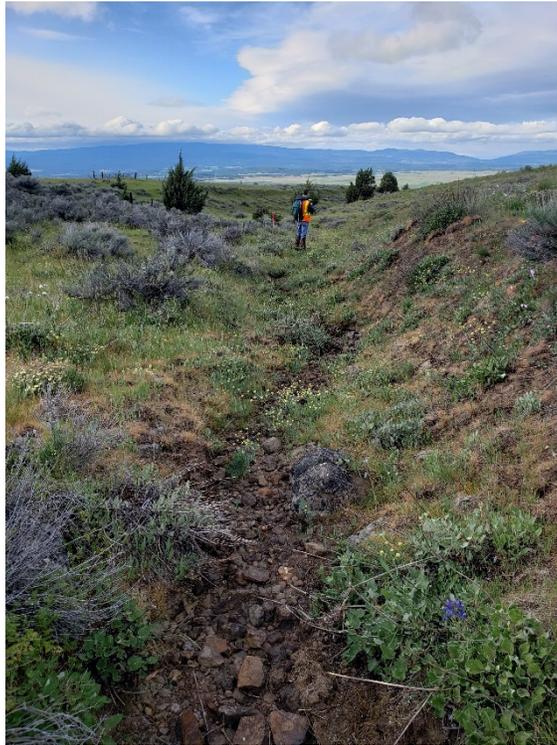
Photo 15: S8, Looking North

Feature S8 is identified as a perennial watercourse in both the NHD and NWI datasets that is located near the upper reservoir. However, based on observations during the May 2019 wetland and waters delineation this feature is an ephemeral stream channel that is 12 to 24 inches wide, 1 to 3 inches deep, and extends approximately 990 feet into the study area; the NHD and NWI show this feature about 770 feet shorter than the extent mapped by ERM. Evidence of an OHWM included an incised bed and bank, sediment sorting, and debris wracking. Substrate consists of small cobbles, gravels, and fines. Although no flowing water was observed, several pockets of standing water were observed and much of the substrate was covered with algal matting. Vegetation along S8 is similar to the species described along S7.

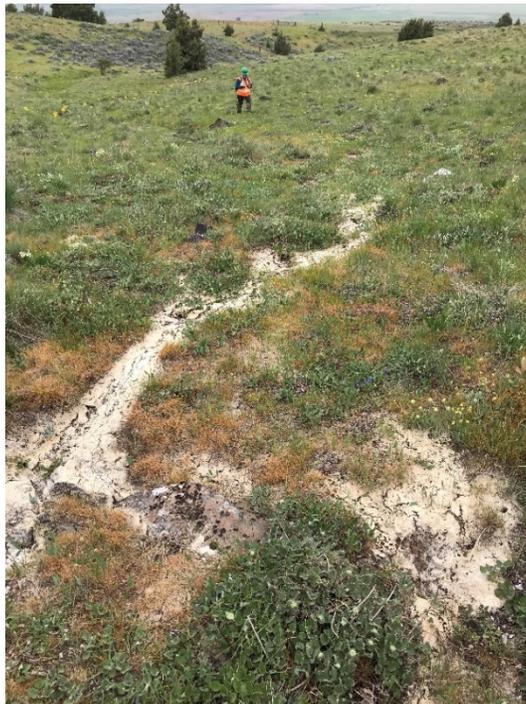
Photo 16: S8, Looking South
